Township of South Frontenac
Municipal Stormwater Management System

ECA Number: 166-S701

2023 Annual Report

W. Troy Dunlop, C.E.T.,
Manager of Engineering and
Capital Projects
Public Services Department
Date: April 30, 2024

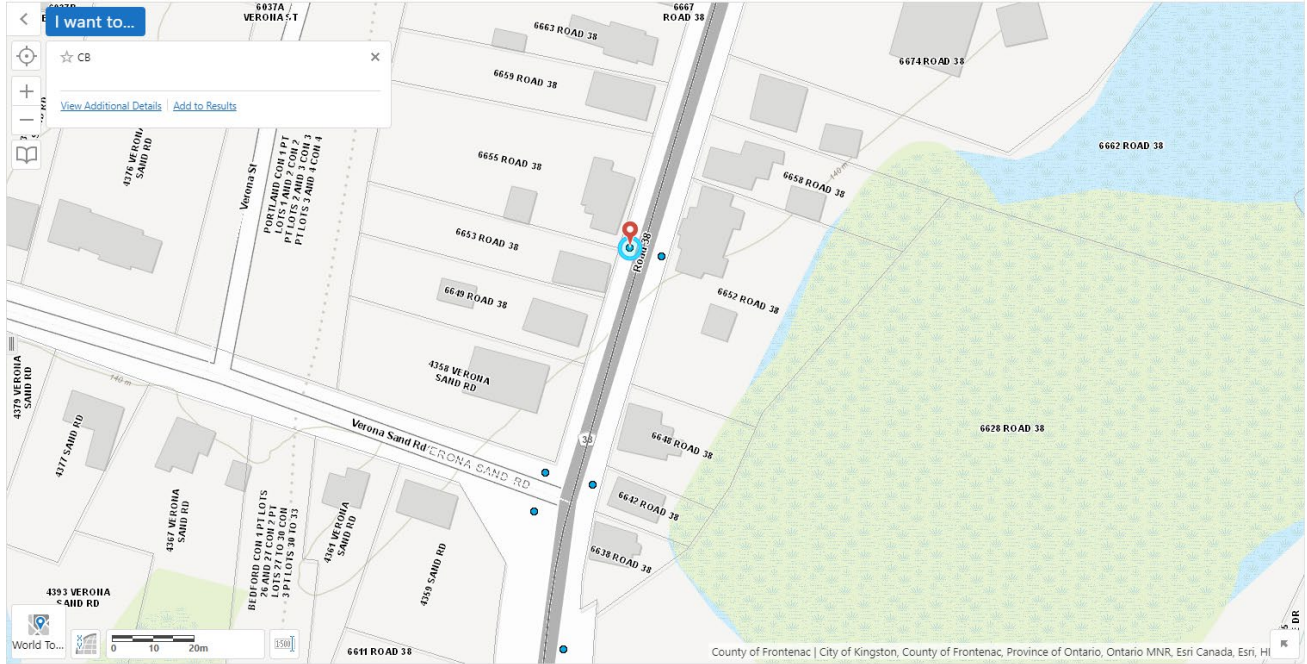
Fronting Civic # 6653 Road 38

Township staff carried out follow up field inspections of the cleaned structures, each of which were marked in the field with a green paint mark. Three (3) catch basin frames in the Village of Verona on the west side of Road 38 were identified as needing repair along with one (1) catch basin frame in the Village of Hartington. Refer to location details in Appendix B and C.

- ii) October 2023 (Verona) – The Township retained the services of a Contractor to excavate and repair three separate catch basins along the west side of Road 38 in the Village of Verona that had settled under traffic loads. Structures were located on Road 38 in front of civics # 6653, 6769 and 6849. Each of the structures was excavated, new grade rings added, new ironworks placed, and adjusted to match the paved surface. This work was completed between the period of October 23rd and October 26th.
- iii) October 2023 (Harrowsmith) - An additional catch basin was also excavated and replaced by the same Contractor in front of the gas station at 5589 Road 38 in Hartington on October 31st.

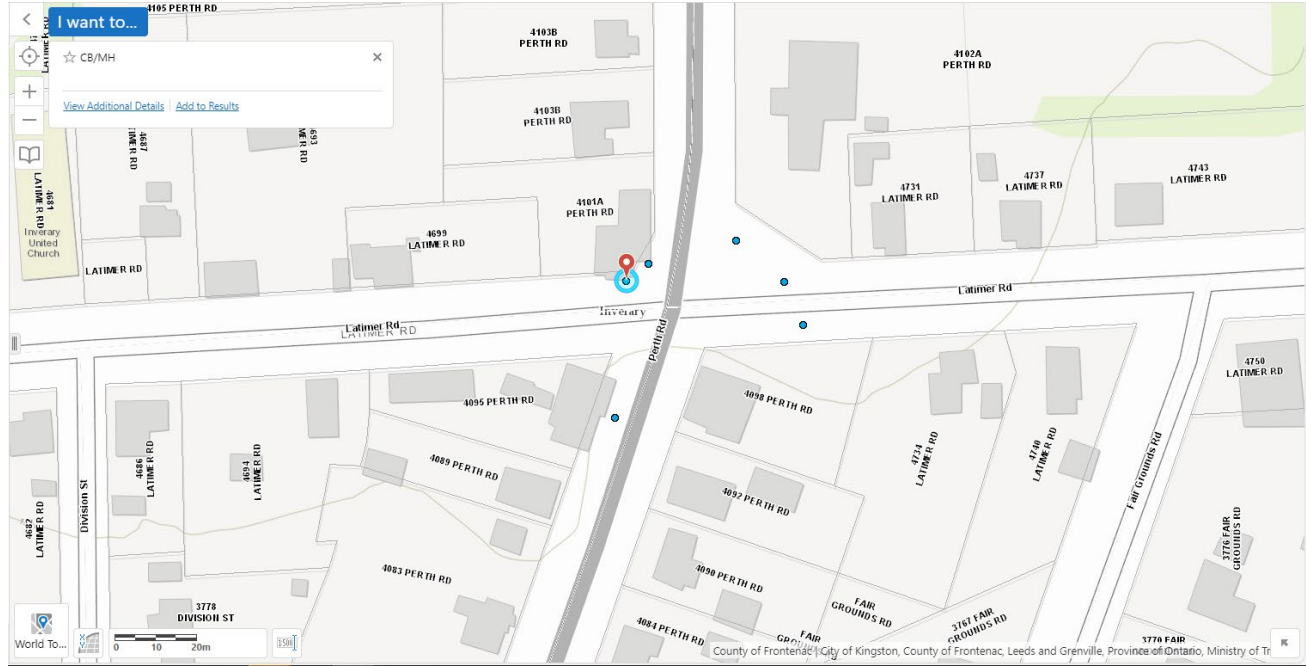
Fronting Civic # 4401 Perth Road

- i) On October 11th, 2023, staff carried out an inspection of a sink hole at the NW corner of the intersection of Latimer Road and Perth Road in the Village of Inverary. Upon review it was identified that road materials were washing downward into an open joint between the catch basin wall and the downstream pipe. The dig area was located within the area of the local traffic signals therefore short-term repairs were initiated while a larger repair activity was planned.

On November 14th, 2023, the Township hired a Contractor to excavate the catch basin structure and repair the open joint between the catch basin wall and the downstream corrugated steel pipe. The area was backfilled, recompacted and the structure was readjusted to accommodate normal surface drainage. Refer to location details in Appendix D.
